EB1814

A KEY TO IDENTIFICATION
OF PACIFIC NORTHWEST
WOOD-DESTROYING
PESTS BASED ON
WOOD DAMAGE

By **Art Antonelli**, Ph.D., Washington State University Extension entomologist,
WSU Puyallup Research and Extension Center; **Terry Whitworth**, Ph.D.,
Whitworth Pest Solutions, Puyallup; and **Dan Suomi**, Ph.D.,
Pest Control Operator Specialist, WSDA, Olympia

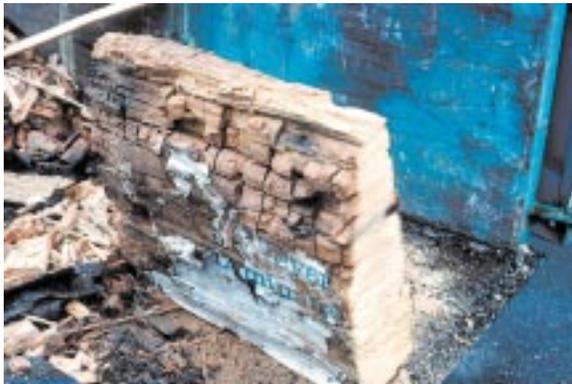
Fig. 1. Wood decay fungi in a support beam damaged by rain leakage.

No galleries, chambers, exit holes, or tunnels, visible in wood; lengthwise or right angle cracks in wood; reduced weight; wood may crumble to powder when compressed.

(Fig. 1). Wood Decay Fungi

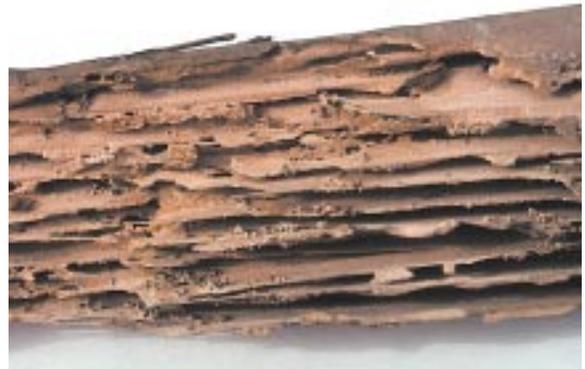
Fig. 2a. Damage and fecal pellets of dampwood termites.

Pellets are $\frac{1}{16}$ * inch long; damaged wood is or has been wet (common in Pacific Northwest)

(Fig. 2a-damage and Fig. 2b-top). Dampwood Termite

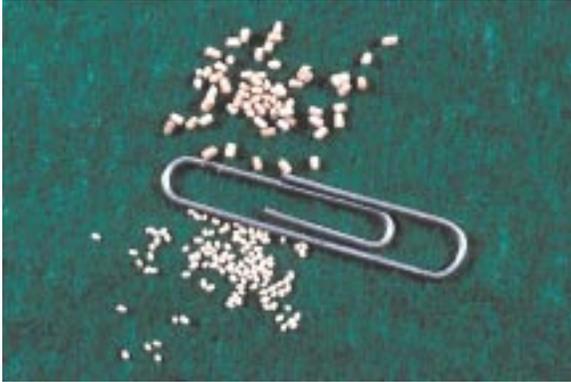
Fig. 2b.
Fecal pellets of dampwood termites—top;
drywood termites—bottom. Standard 1¹/₄-
inch-long paper clip shown for scale.

4. Pellets are $\frac{1}{32}$ inch long; damaged wood appears dry (occasional import to the Pacific Northwest)

(Fig 2b-bottom). Drywood Termite

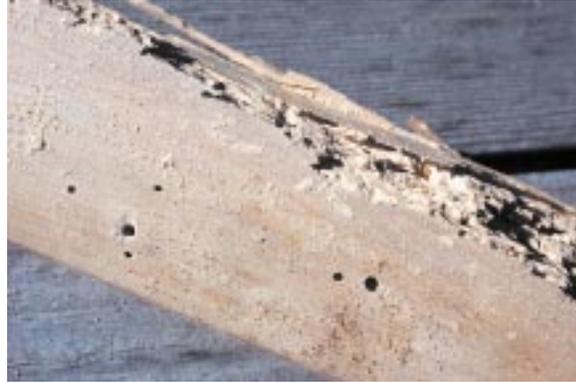
Fig. 3.
Shot holes in wood. (Lyctid or
powderpost beetle exit holes.)

5. Small exit “shot” holes in wood ($\frac{1}{32}$ – $\frac{3}{32}$ inch); wood often crumbly and full of powdery microscopic pellets **(Fig. 3)**. 6

(Fig. 4a-pellets-left; Fig. 3-exit holes; Fig. 4d-damage). Lyctid Beetles

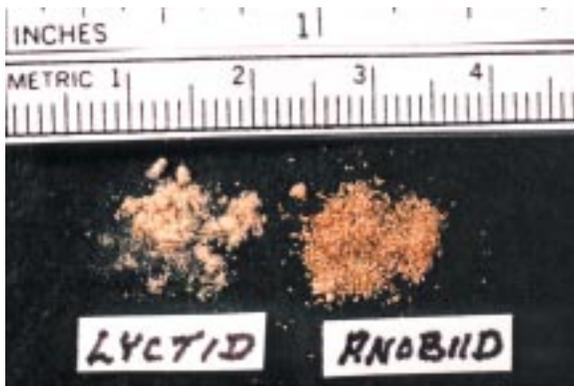
Fig. 4a.
Fecal pellets (frass) of lyctid beetles—left;
fecal pellets of anobiid beetles—right.

6. Pellets granular (gritty); usually in softwoods (Douglas-fir, etc.) which have been damp; very common west of the Cascade Mountains.

(Fig. 4a-pellets-right; Fig. 4b-exit holes; Fig. 4c-anobiid frass expelled from hole). Anobiid Beetles

Pellets indistinct powdery or talclike (like flour); in dry hardwoods (oak, etc. or bamboo)

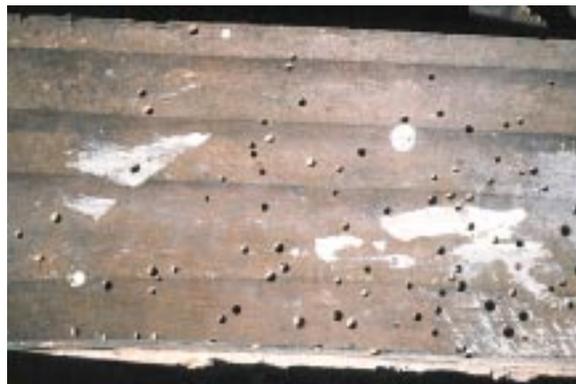
Fig. 4b.
Anobiid or deathwatch beetle exit holes.

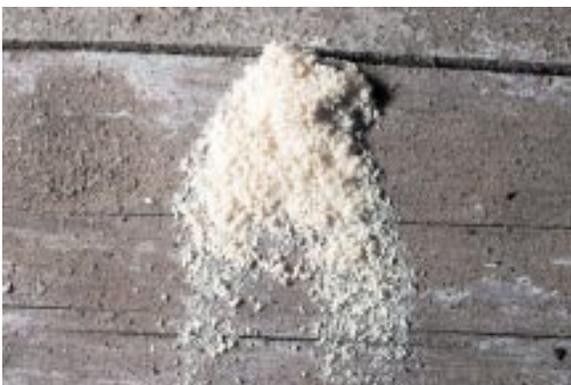
Fig. 4c.
Anobiid frass expelled from hole.

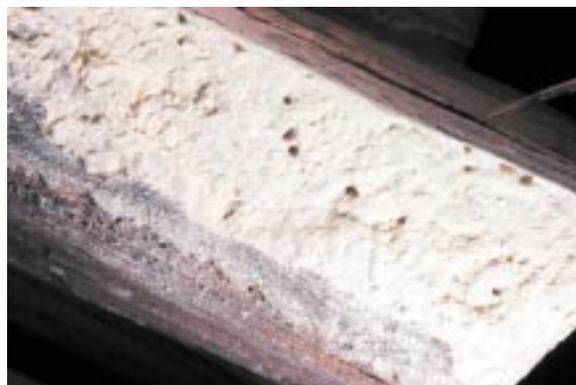
Fig. 4d.
Lyctid beetle damage.

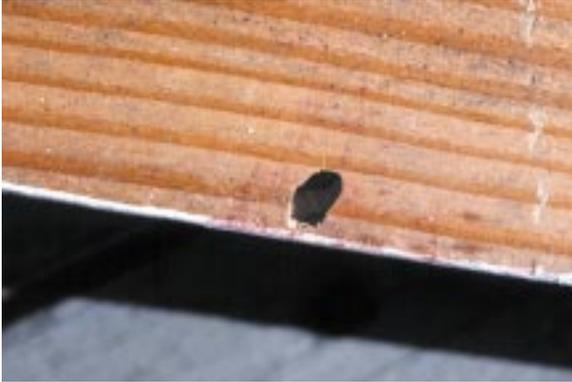
Fig. 5a.
Buprestid beetle exit hole.

7. Tunnels in wood flattened; 3 times as wide as high; oval exit holes; concentric arc pattern present in gallery.

(Fig. 5a and b). Buprestid (flat-headed) Borers

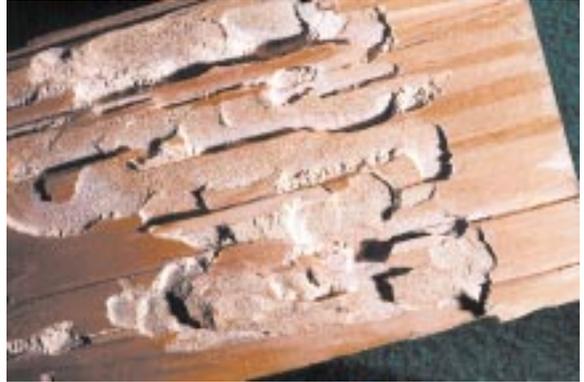
Fig. 5b.
Buprestid beetle larval mines.

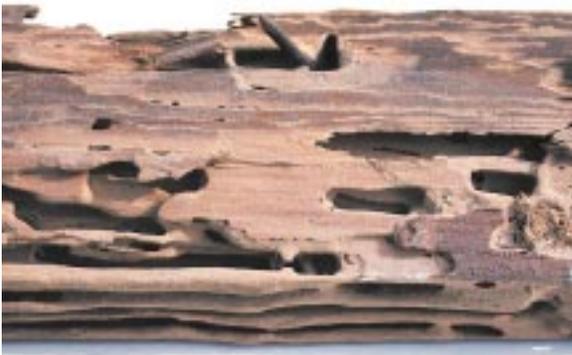
Fig. 6.
Carpenter ant galleries (note sawdust fragments in lower right quadrant).

9. Excavations larger (about 1/4 inch), very smooth and clean. (Fig. 6). Carpenter Ants

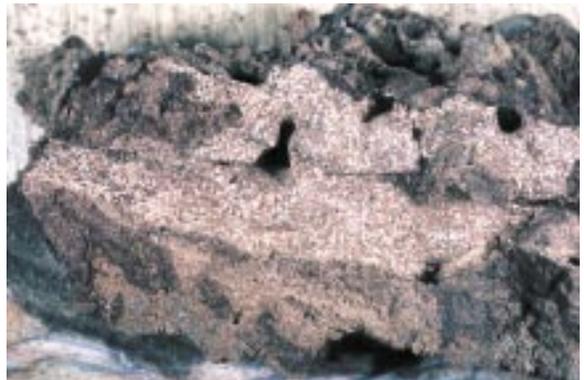
Fig. 7a.
Subterranean termite "scaling."

10. Excavations usually in sound wood; scale-like speckling in galleries; no sawdust present; mud tubes on wood. (Figs. 7 a, b, and c). Subterranean Termites

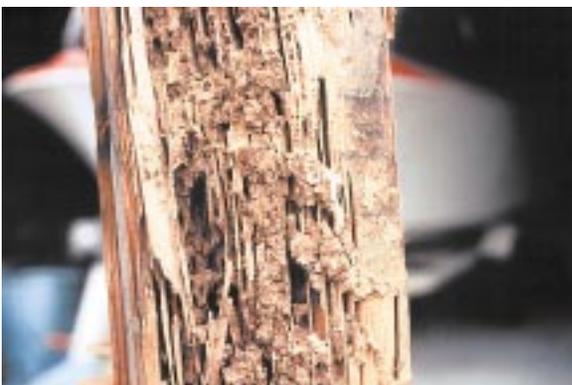
Fig. 7b.
Subterranean termite damage.

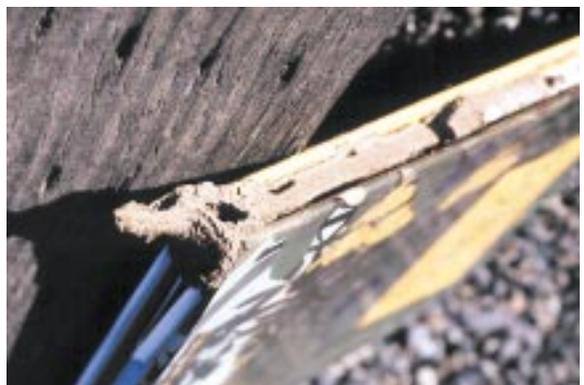
7c.
Subterranean termite mud tubes.

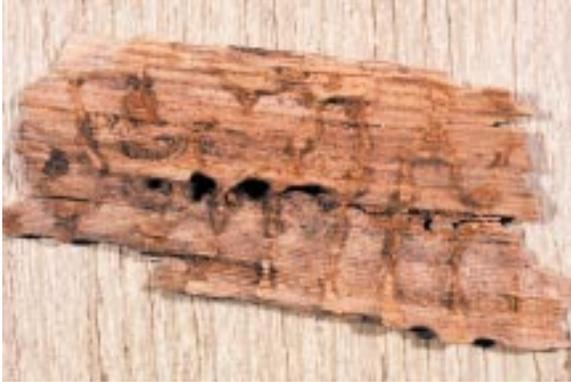
Fig. 8a.
Moisture ant damage.

Excavations in wet, rotted wood; no scale-like speckling in galleries; dark discolored sawdust, sometimes used to form protective tubes. (Figs. 8 a, b, and c). Moisture Ants

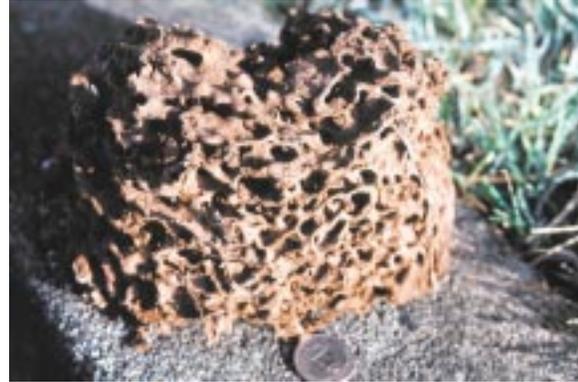
Fig. 8b.
Moisture ant galleries made from
damaged pressboard.

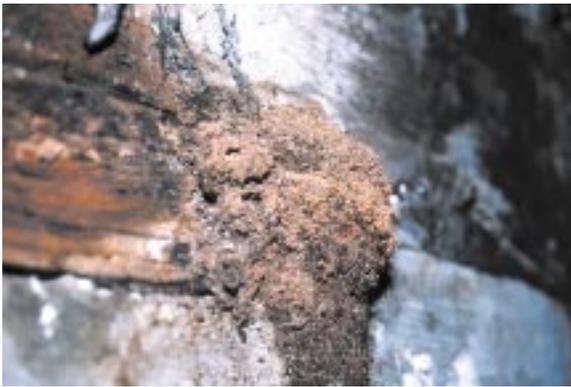
Fig. 8c.
Moisture ant colony on a mudsill
in crawl space.

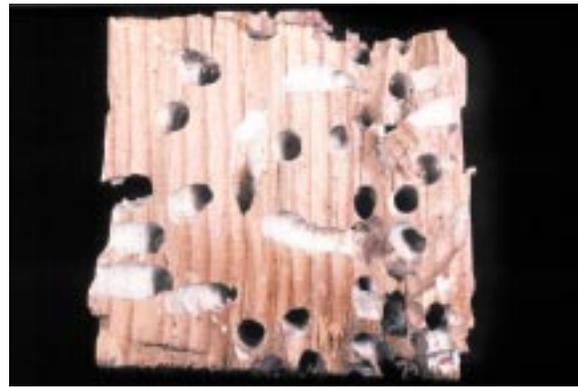
Fig. 9.
Teredo or shipworm damage.

8. Excavations lined with white calcareous (calcium) materials found only in wood that spent time in salt water.

(Fig. 9). Teredo or Shipworm
